HARTWELL LAKE PROJECT
Savannah River, Georgia And South Carolina

REHABILITATION OF CLEMSON UPPER DIVERSION DAM

CONTRACT NO. DACW21-83-C-0066

CONSTRUCTION FOUNDATION REPORT

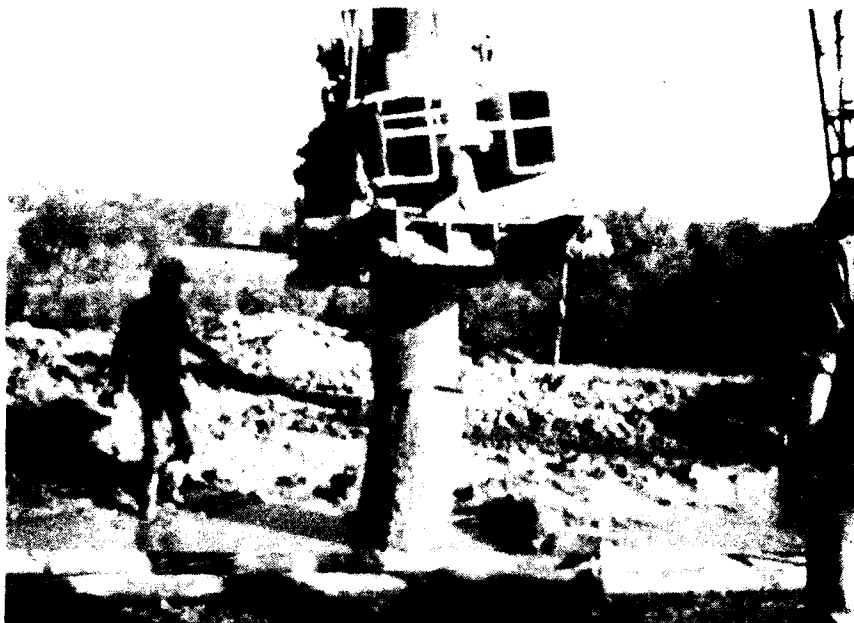
Photo 50 - Broken shoulder pipe in Panel 23 (April 25, 1984)
